COMPARATIVE EVALUATION STUDY OF ON-LINE CAMERA-BASED WEB INSPECTION SYSTEMS

COMMISSIONED BY THE
AMERICAN FOREST AND PAPER ASSOCIATION
MEASUREMENT TECHNOLOGY COMMITTEE
(AF&PA/MTC)

Evaluation of the R.K.B.® OPTO-ELECTRONICS, INC.

MODEL 3030® OPTOMIZER® Camera-based Video Web Inspection System for Holes, Flaws, Coating Streaks and/or Scratches

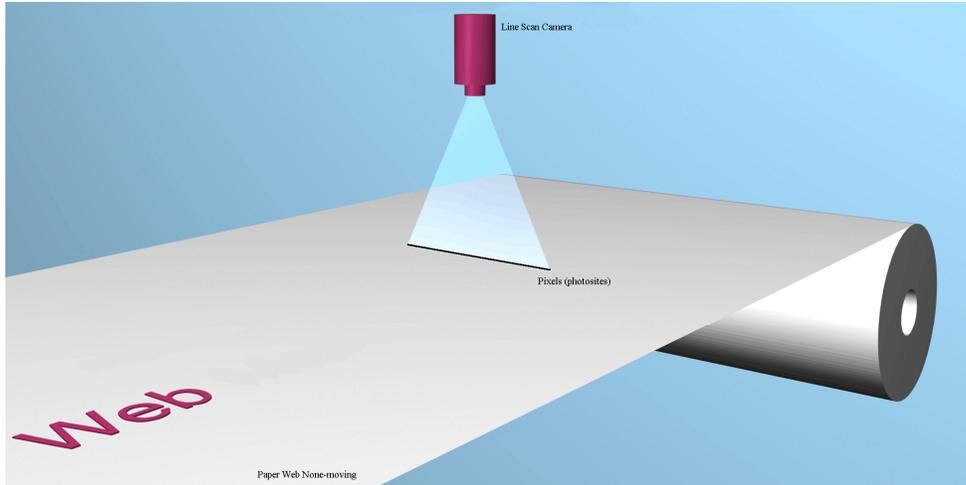
Figure 3 - Cross machine pixel resolution on a stationary web or "Static Resolution"

CCD camera based web inspection suppliers typically define system resolutions (or minimum defect size) as the field of view (FOV) per sensor in the cross machine direction divided by the number of pixels contained within that sensor. That means a 2048 pixel linear array camera viewing 20 inches (50.8 cm) of material in the cross machine direction should have a resolution of slightly less than 10 thousandths of one inch (0.254 mm) or the size of the pixel resolution in the cross machine direction (Table 1).

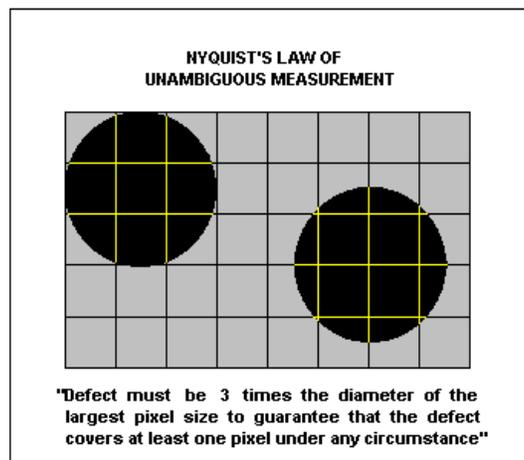
Figure 4 – Nyquist's Law of Unambiguous Measurement

Another factor, which has a direct affect on system resolution capability, is Nyquist Theorem. In 1928, Henry Nyquist determined that, when sampling at a given rate, the highest frequency that can appear in the sampled signal is half the sampling frequency. If the sampled signal contains frequencies higher than half the sampling frequency (higher than 4 kHz when sampling at 8 kHz as is the case for μ -law), these higher frequencies will appear folded down to below half the sampling frequency when the signal is reconstructed. This is the Aliasing problem. This problem, commonly referred to as Nyquist's Law of Unambiguous Detection Measurement, states that the "Defect or event being inspected must be 3 times the diameter of the actual pixel coverage size to guarantee that the defect fault or event covers at least one full pixel under any circumstance (Figure 4).

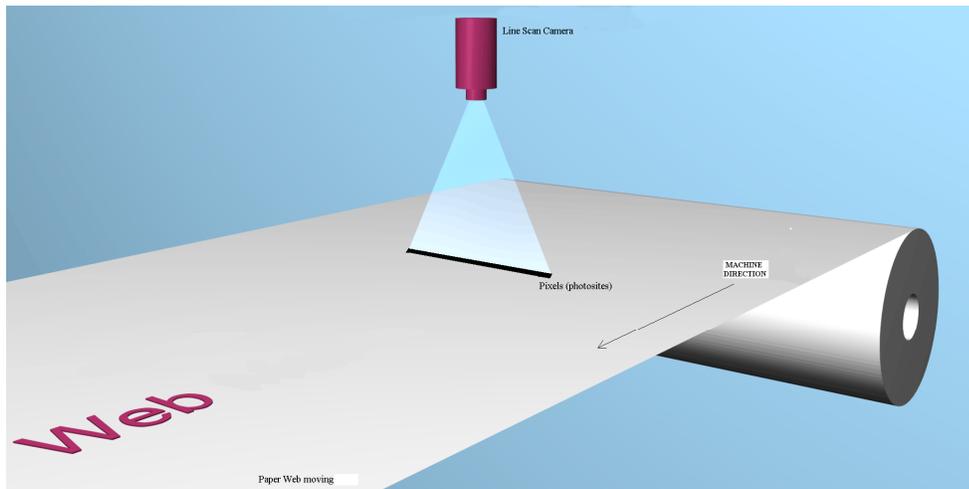
Figure 5 – Machine Direction pixel resolution on a moving web or “*Dynamic Resolution*”

It is fairly easy to estimate what true resolution can be expected for any CCD array as applied to any potential inspection application. Thus, a best-case and worst case resolution scenario can be determined. First of all, two pieces of data are required to effectively calculate the true resolution of any CCD camera based solution. You need to know the cross machine direction resolution (CDR – commonly referred to as static resolution; *Figure 3*) and the machine direction resolution (MDR – commonly referred to as dynamic resolution; at speed; *Figure 5*) per pixel. These two resolutions, when calculated together, determine the true operational pixel resolution for a particular application.

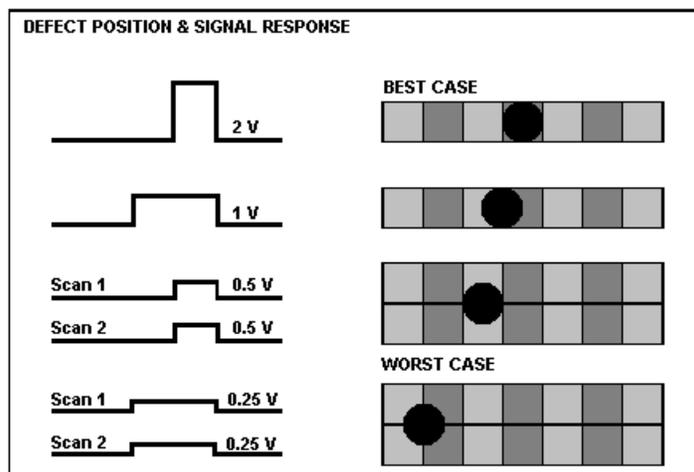
Figure 6 – Best Case/Worse Case Signal and Defect Resolution Response

Every CCD camera-based solution, no matter what CCD pixel array you use, has a best case and worst-case resolution scenario. If a defect fault or event covers the full pixel, either in a static environment or dynamic environment, the voltage signal output is at its highest optimum level or full modulation (*best case*). However, in reality one has to deal with machine process speed, various energy levels, and web tension control fluctuations, web wander, shrinkage and other variables generally not present during inspection in a static environment. All these factors can seriously alter your best case resolution scenario. Another “real-world” issue that most suppliers neglect to consider is the relative timing between a defect fault or event during any one particular CCD pixel array scan. Unfortunately, reality being such as it is, many defect faults or events cover only a portion of the full pixel during any one scan and the resultant voltage signal output is reduced from its optimum level or modulation. It is quite feasible that a defect fault or event could fall on a quarter of the pixel coverage providing only a 25% optimum voltage level output or modulation (*worse case*). Refer to Figure 6 for a depiction of the best case and worse case signal responses.

As seen above in *Figure 6*, when a defect fault during a CCD linear array scan lands completely within the pixel, the resultant voltage level output is at full modulation or 100%. However, when the defect fault lands on the crosshairs, so to speak, upon completion of one scan and initiation of another, approximately $\frac{1}{4}$ of the defect fault is detected resulting in $\frac{1}{4}$ modulation or 25%. This phenomenon, which can reduce the ability of the detection process, can be avoided if proper and direct care is taken prior to manufacturing a system to take the possibility of decrease modulation into account. Additionally, the reduction in defect modulation dramatically gets worse when machine process speeds are increased. Of course, lighting which is another factor, can play an important roll if you cannot generate enough energy to run the CCD array at optimum scan rates.

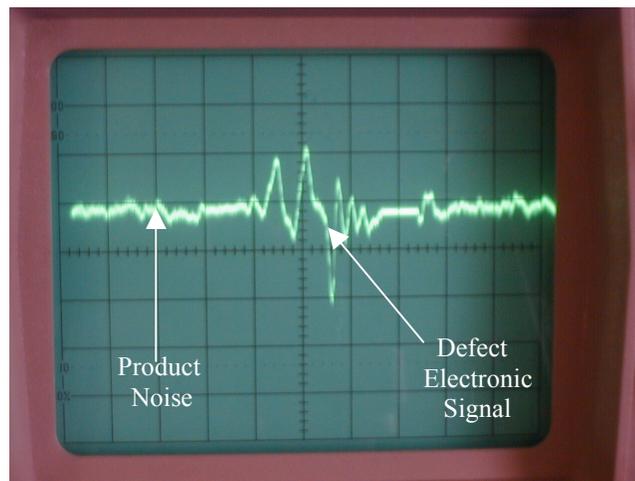
Figure 7 - Signal to Noise Level of Defect Vs Material

As with all inspection solutions, the resultant output obtained from the electronic processing modules is an electronic signal. In this signal you have what we call noise (generated by the product itself). From that noise, you have discrete voltage spikes that may or may not be defect faults (*Figure 7*). This overall signal is referred to as the signal to noise ratio. In most cases, one would want a signal to noise ratio of 3:1 or better, with 3 representing the defect and 1 representing the noise. However, since reality shows that defects do not necessarily land and cover a full pixel in any given scan, as shown in *Figure 6*, the resultant voltage levels become lower and more difficult to discern. This phenomenon is especially true with subtle dirt and coating streaks/scratches. Under a static environment, all sensors should produce similar results with similar outputs. However, when machine speed is applied to the equation, the defect may not provide the optimum modulation during detection to provide a reliable output signal. This has been demonstrated in the paper industry time and time again. RKB Commonly hears from papermakers that the units they currently use are so sensitive and see everything that they have to reduce the detection threshold. This was a common statement made when Laser Systems had their hey day. What is actually occurring is that the defect electronic signal is not strong enough nor contains significant characteristic changes for the inspection system to pick out the defect from the random noise. As such, the inspection system is rendered for all intent and purpose, useless.

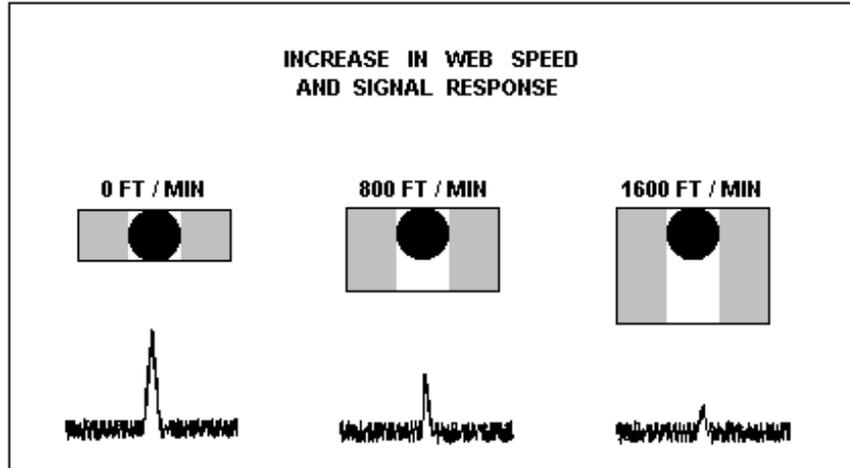
Figure 8 – Effects of web speed on the defect signal to noise ratio

For example, lets take a 1/32" (0.8mm) black spot on a white paper. Apply machine speed to the paper web and increase said speed accordingly. As you can see in *Figure 8*, the detection capability of the CCD linear array chip set deteriorates due to the fact that the defect fault or event is no longer falling or covering one full pixel, but only part of a pixel during any given scan. Therefore, the modulation of the defect electronically starts to decrease until it become completely immersed within the noise level of the product material itself.

Another phenomena that hinders reliable detection with CCD's, unless taken into account, is pixel stretch. Again, as you can see in *Figure 8* above, as you increase the machine speed, the machine direction resolution per pixel also increases or stretches. This affect causes the total area covered by the pixel to increase. Therefore, if you are looking at a 1/32" (0.8mm) black spot that covers a full pixel in static mode (left view in *Figure 8*), the same size spot will cover less of the pixel as machine speed increases until the modulation level of the voltage signal decreases to the point of non-detection (right side view in *Figure 8*). Now, take a white colored streak on white-coated paper and apply the same principal. Not only does the contrast level significantly decrease, but streak detection no longer can be done using line scanning technology as there is no way of being able to bring the subtle defect out of the noise level if your pixel coverage is, lets say 2mm wide by 10 mm line and your fault is only 5% or 10% of that coverage.

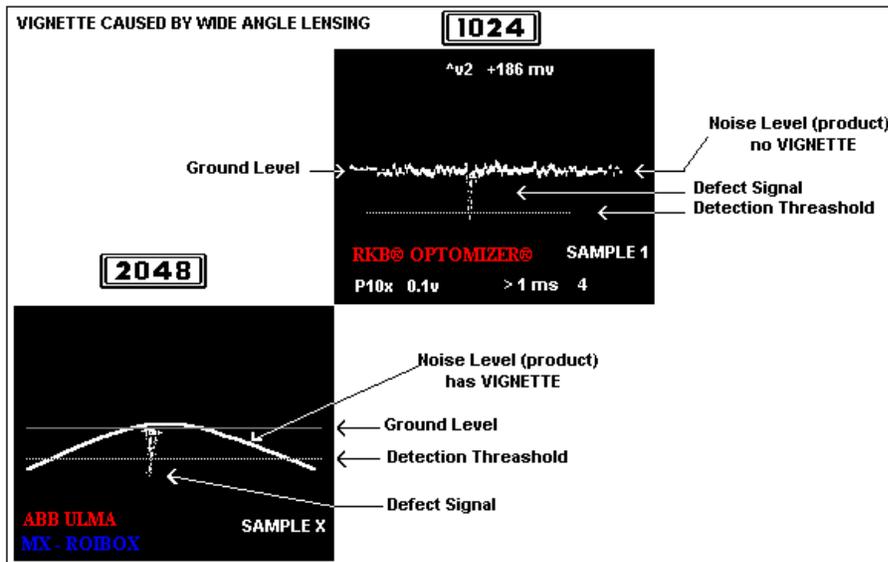
Figure 9 - Vignette Affect on Electronic Signal resulting from Wide Angle Lensing

Earlier we mentioned that wide angle lenses also affects reliable detection. The main reason why suppliers of inspection systems would use this type of lens is to facilitate the use of as few sensors as possible, keeping costs down while maintaining profit margin. Although some applications would require the use of wide-angle lenses, main stream paper inspection is not one of them. Utilizing wide-angle lenses creates Vignette (*Figure 9*). Vignette is defined as "an image that shades off gradually into the surrounding background."

Vignette applied to the electronic output signal of a paper defect fault or event, the defect eventually fades off into the noise level of the product material itself seriously degrading the detection systems capabilities for reliable, accurate and consistent detection. This becomes more apparent towards the outer fields of view of the sensors. It is RKB's opinion, although commonly used in our industry by others, that wide-angle lenses sacrifices the ability of the detection system to perform for the customer as intended. As seen in figure 9, the top oscilloscope representation shows the RKB CCD solution that is designed without the use of wide angle lenses, thus NO VIGNETTE phenomena affects detection reliability. The bottom picture shows what happens when wide-angle lenses are put in place to reduce the number of sensors required to do the job. The result, serious vignette problems exist.

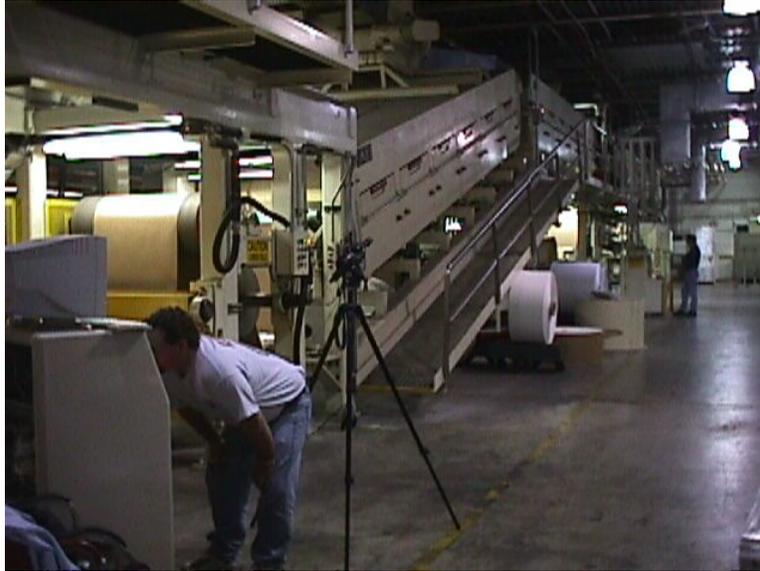
Figure 10 – Pilot Coater Mill Environment

The production machine in which the trial evaluations were conducted was the pilot coater machine located at Appleton Papers, Inc., Appleton, Wisconsin, USA. The machine is located in a separate building away from many environmental conditions that normally are present in the mill. The climate was very clean and dry (Figure 10). All products provided were pre-manufactured thus eliminating the need to actually use coaters and dryers. Vibration from the machine was minimal and ambient light had no affect.

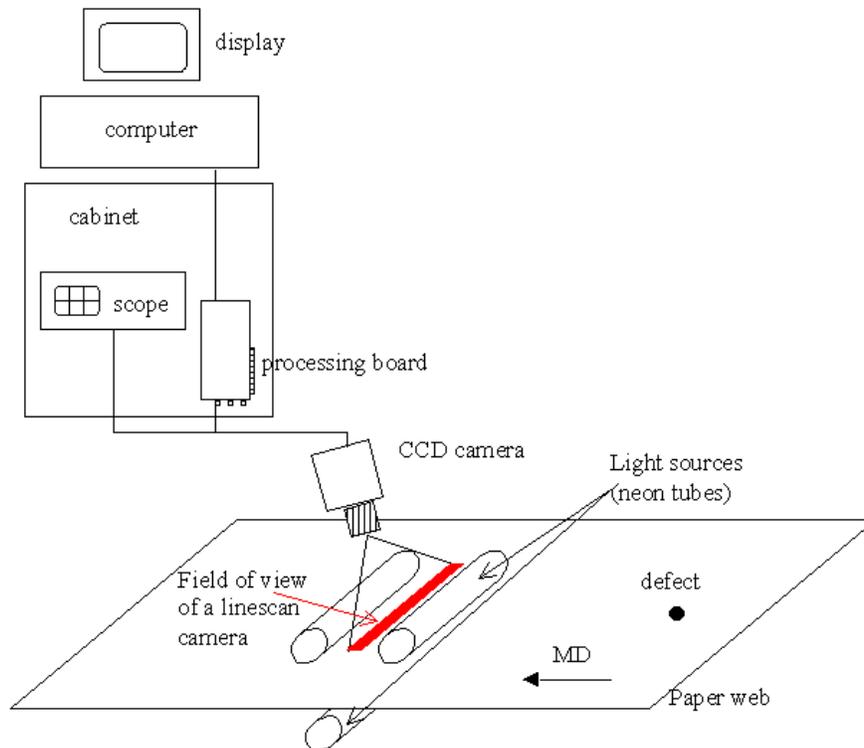
Figure 11 - Diagram of RKB 3030 for discrete defect detection

The model machine evaluated by the IPST and provided by RKB was their Model 3030[®] CCD Camera-based Video Web Inspection System with a true Microsoft Windows NT[®] environment. The machine had two configurations, one for discrete defects such as small dirt and one for subtle continuous defects such as coating streaks. A schematic of the system used for discrete defect detection at Appleton Papers is described in figure 11.

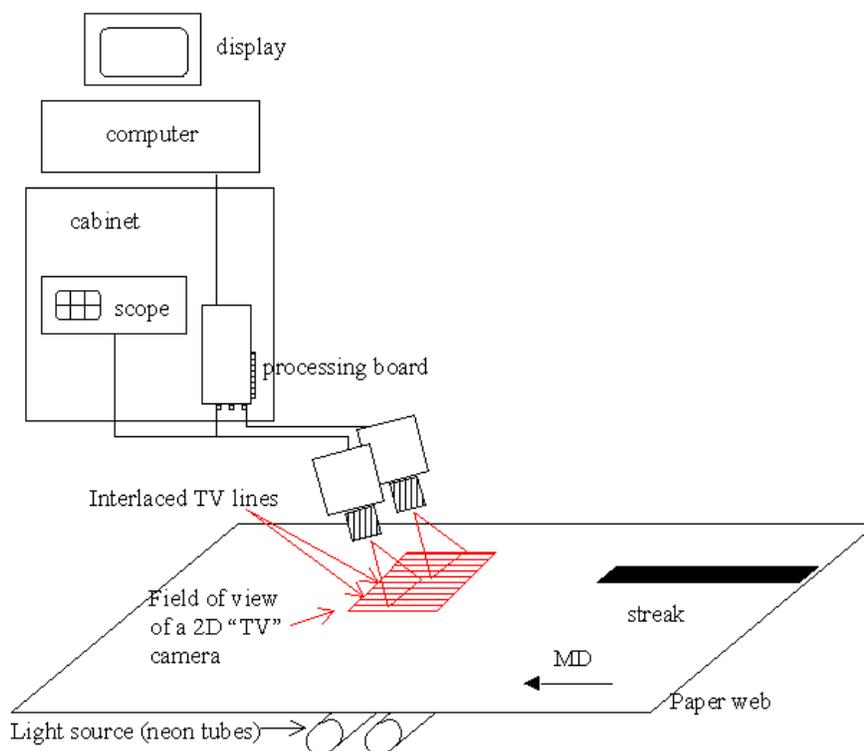
Figure 12 - Diagram of RKB 3030 for subtle continuous defect detection

A schematic of the system used for subtle continuous defects such as coating streak detection, using the same frame, cabinet, electronic processing techniques and computer, but different sensors and lighting techniques, is shown hereafter (Figure 12):

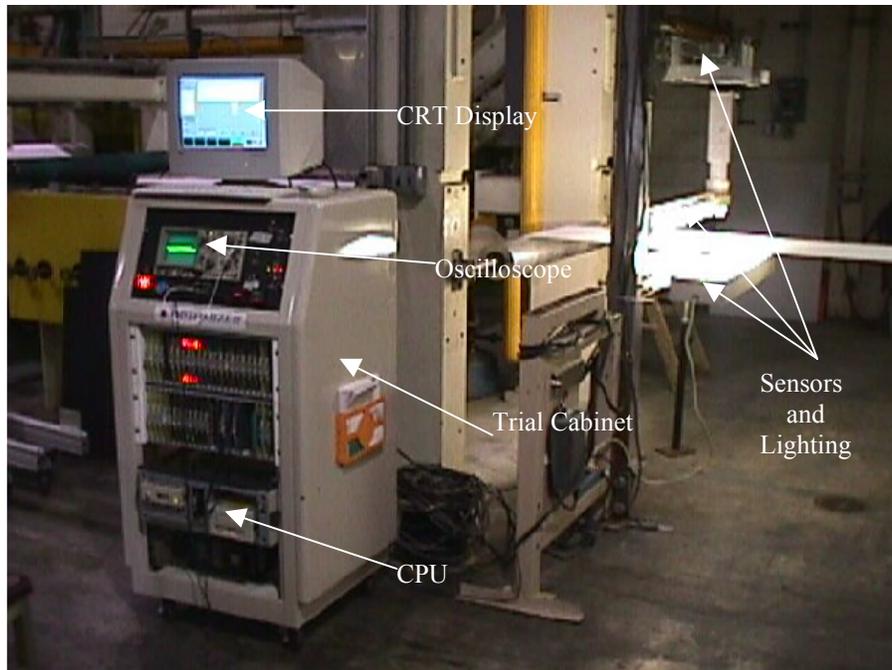
Figure 13 - General view of RKB Model 3030 used for evaluation in Appleton

Figures 13, 14 and 15 show the control, sensor, lighting and interface sub-units of the Model 3030 in greater detail. These sub-units are designed with flexibility in that, they can deal with the detection of holes only, dirt only, hole/dirt, streaks only or all defects that can occur during the process of coated and non-coated material manufacturing. The neon tubes and the sensors are attached on the same frame.

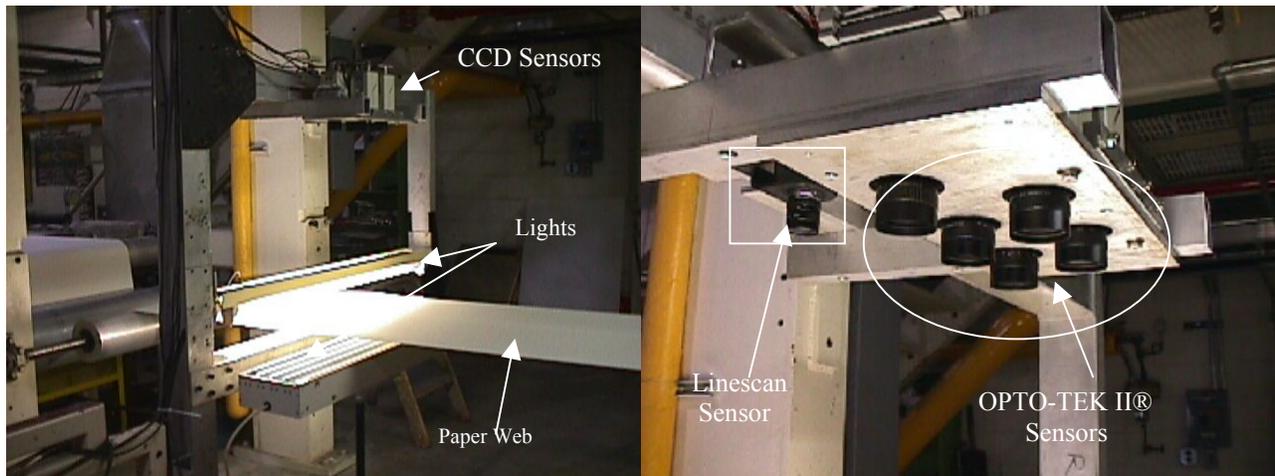
Figure 14 - View of frame support, lighting and sensors

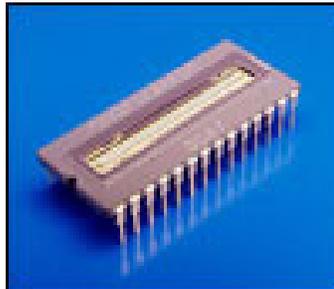
Figure 17 - OPTO-TEK I®

Regarding the directives set fourth by the IPST, RKB modified their existing demonstration sensing head assembly around their Opto-Tek I™ (Figure 17) and Opto-Tek II™ (Figure 18) technology with a specific field of view per sensor to achieve the defect detection specifications as submitted by the IPST. The line scan camera, in this application, used 3 special very high output (VHO) neon tubes for the light source, 2 on top of the web in a reflection configuration to facilitate spot detection and one on the bottom side of the web in a transmissive configuration to facilitate hole detection. The distance from the line scan camera to the surface of the web was 27 inches (686 mm). The field of view (length of the line scanned cross machine direction) was 13.5 inches (343 mm). The sensor contained 1024 pixels that provides a scan rate twice as fast as a 2048 pixel line scan sensor (industry standard). The field of view was slightly less than the total width of the web (30 inches; (76.2 cm)) as RKB used only one line scan sensor for this evaluation due to the evaluation study defect specification and time constraints in providing equipment for the designated evaluation date.

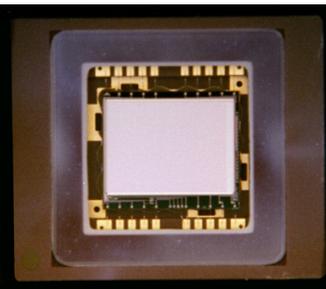
Figure 18 – OPTO-TEK II®

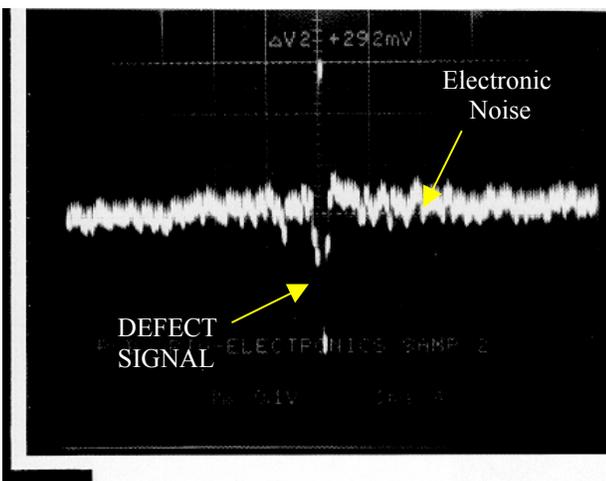
Figure 18 - Signal to Noise Ratio

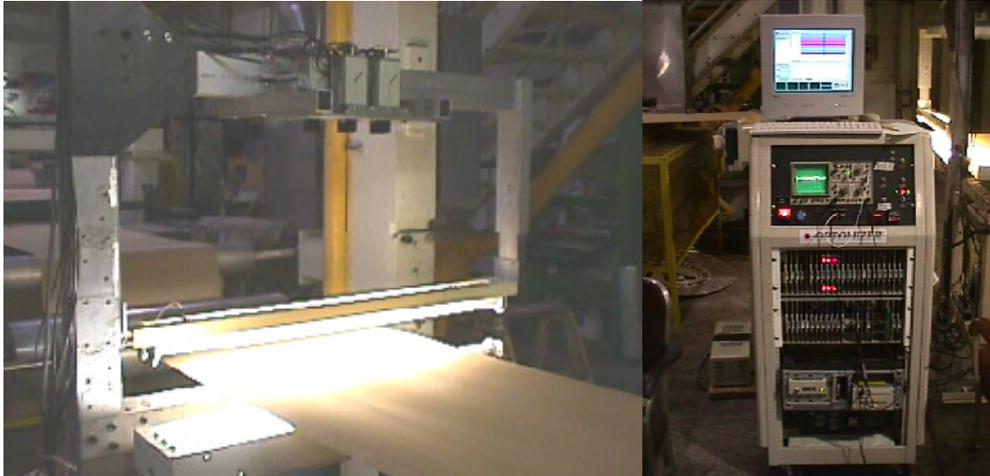
Figure 20 - View of the Inspection Assy and DCS during the trial with the 33-lb Linerboard Export

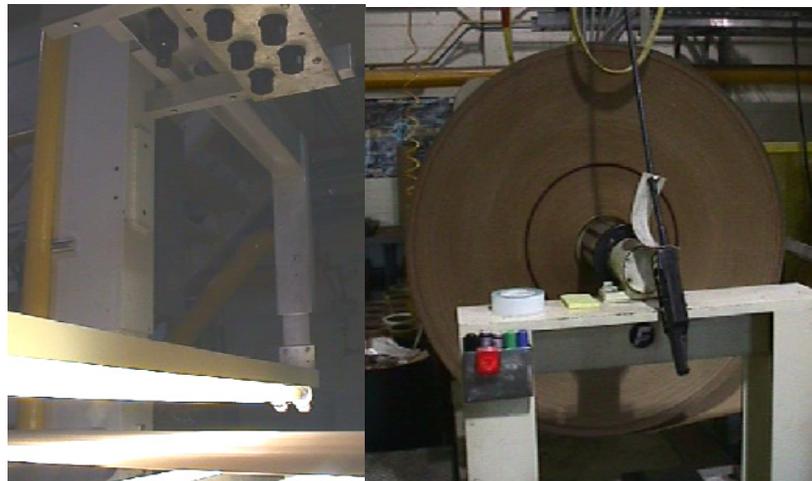
Figure 27 - View of the inspection assembly and the linerboard defect marking during the linerboard export test

In this particular run, some defects were marked for verification of detection. The marks were applied by a colored marker along the edge of the web (Figure 27). During the rewind of this web in preparation for the third pass test, the defects were located and photographed for verification. Figure 28 shows these typical defects that were detected in this grade of paper. The defects included oil, light spot (area of reduced fiber content) and scale. The divisional ruler used was in centimeters with the small graduations in millimeters. This was very significant in helping justify the detection capability of the system and to verify the software and hardware verification and classification set up.

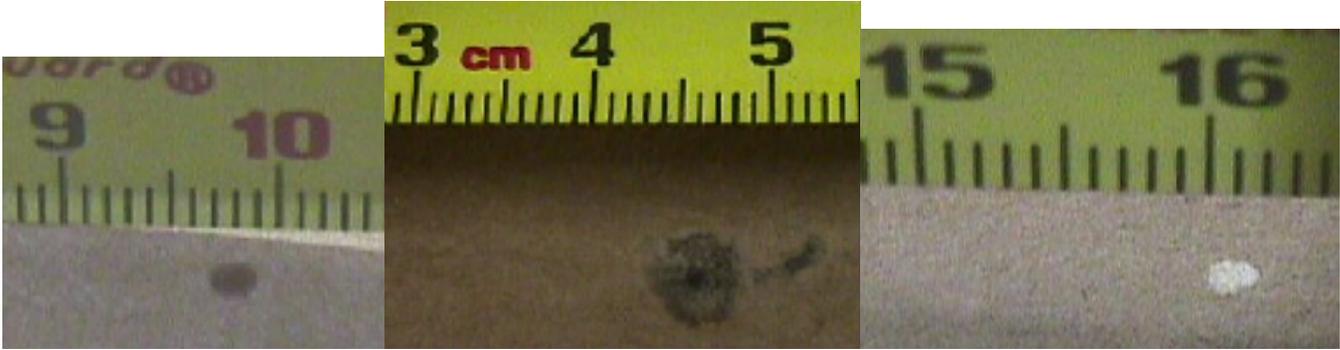
Figure 28 – Pictures of defects detected at production speed during the 33-lb Linerboard Export Test. Defects include a light spot, oil and type of scale

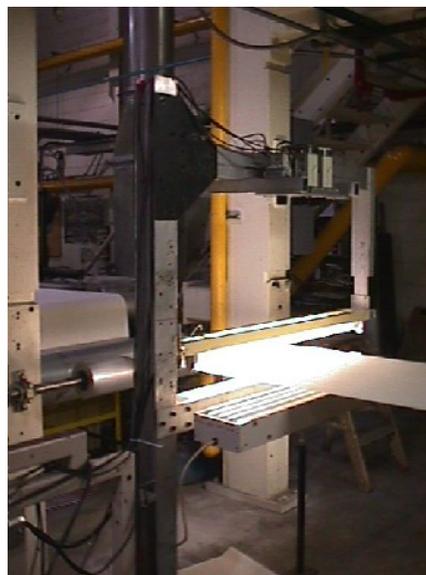
Figure 22 - View of newsprint roll A sagging prior to inspection due to excessive web flutter

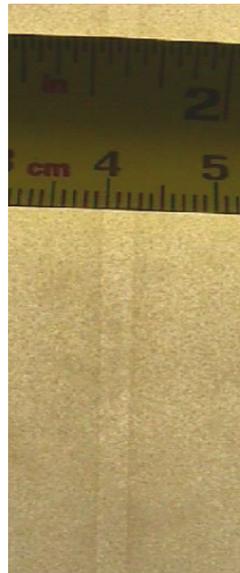
Figure 24 - Picture of a coating streak detected by the RKB Model 3030 during the Choctaw Matter Roll A evaluation

Again, as in the second run, the coating streak was detected and specified correctly (Figure 31). In this case, the product was not rewound thus the coated side faced the sensor unlike the second run. As with the second run, IPST personnel observed it, the streak jumped from camera to camera just after the splice. In this case, it jumped from camera two to camera one. Upon completion of the test, the roll was taken away and IPST started preparation for the next coated grade, Accolade Gloss Roll A.

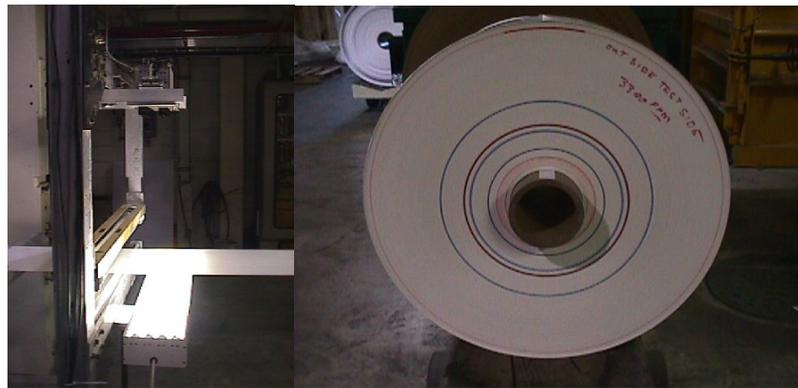
Figure 32 – View of inspection assembly during run and a picture of the Accolade Gloss Roll with defect location marks.

The test data and evaluation indicated that the unit was setup correctly and no apparent adjustments were required or performed. The defection threshold for activation of streak defects was set at <0.4 volts for narrow, 0.4 volts to 1.2 volts for medium and 1.2 volts for large. The unit indicated streak detection and was verified not only by the systems software, but by a small Sony TV monitor that is included with part of the unit for visualization. Additionally observed by IPST and RKB personnel were additional streaks that appeared to come and go quite frequently. These signals appeared to move right and left along the cross direction of the web. These scratches appeared on both sides of the web. The characteristics of the scratches were such that reflected light most likely would be required for more consistent pick up. The wider and more apparent streaks were observed by IPST, Appleton and RKB personnel and were visually verified via the TV monitor, data logging and by the oscilloscope. The roll of paper was marked upon detection of the large coating scratches with blue ink on the side of the web indicating location (Figure 32).

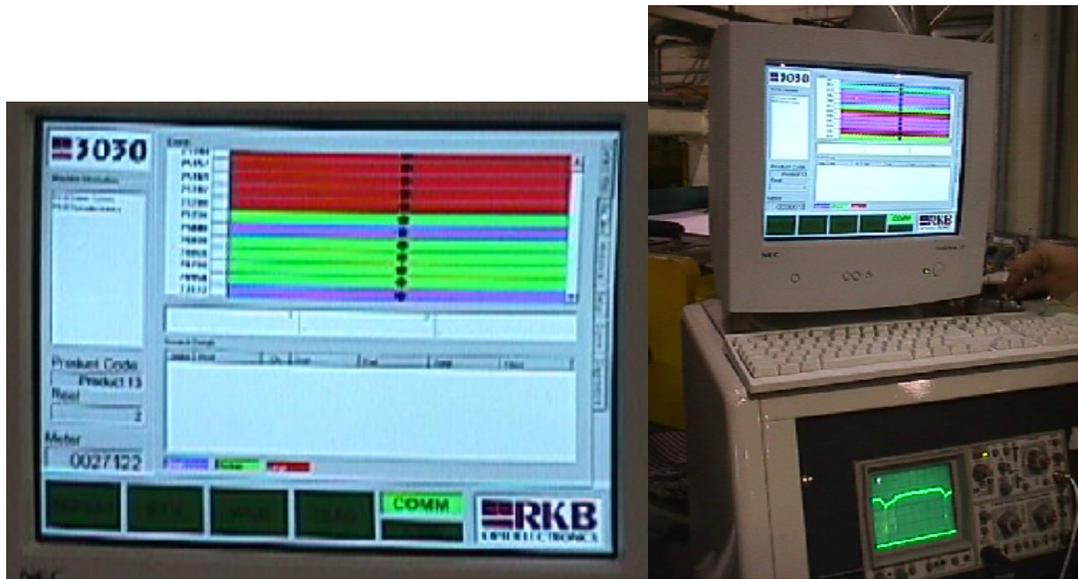
Figure 33 - View of cabinet and CRT screen during trial with calibrated defects. Each Red strip indicates a large size defect, Green medium and Blue small.

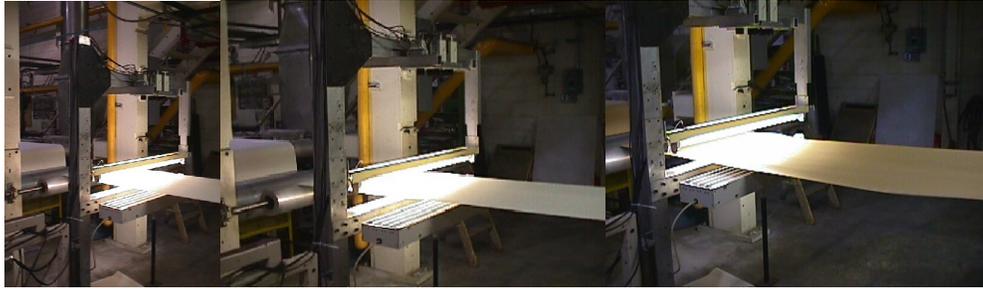
Figure 34 - Showing the web sagging problem during the Newsprint A trial run that contributed to web breaks.

After some adjustments we were finally able to reach 5000 fpm (000 m/min) and start acquiring data. Then after five seconds of data acquisition at 5000 fpm the web directional control couldn't respond fast enough. A web break occurred that caused a huge paper Jam (Figure 35). A long section of the roll was lost and the roll was split into two rolls with the smallest roll not negligible in diameter. Both rolls were removed from the machine.

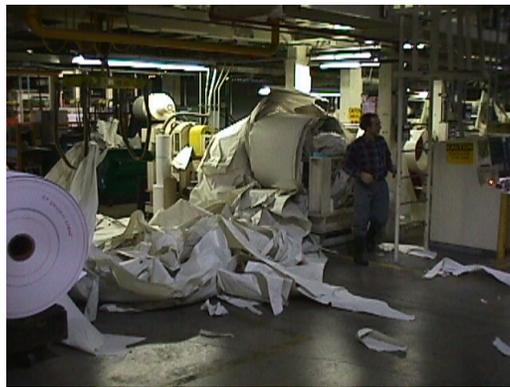
Figure 25 - Web Break of Newsprint Roll A

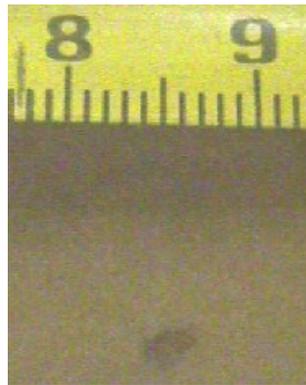
Figure 26 - Picture of spot defect detected during linerboard import test run

That data collected (Table 29 above) was favorable according to the settings and conditions. The web exhibited quite a lot of sagging and flutter, which affects the detection capability as the web significantly moved in and out of focus to the sensor. This problem may have been caused by mechanical problems in the pilot machine during the break problems the day before when operational speed was running up to 5000 fpm (000 m/min). The outside surface of the web was facing up towards the sensors. During this test, the footage module was not connected so it was not possible to know exactly the location of the defects in the web. However, the defect count overall was not affected nor was defect detection. Figure 36 depicts a defect that was detected during this trial run. The divisional ruler used was in metric and divided by centimeters. Each graduation represented a millimeter. The spot defect was approximately 3 to 4 millimeters diameter.

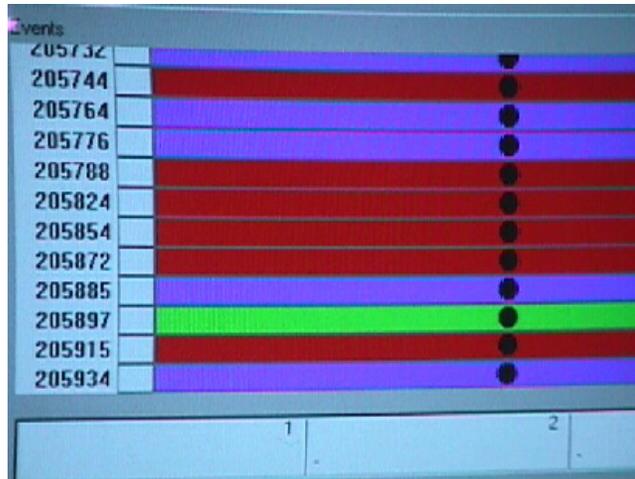
Figure 27 - Real time mapping of defects. All defects are dark spots of different sizes

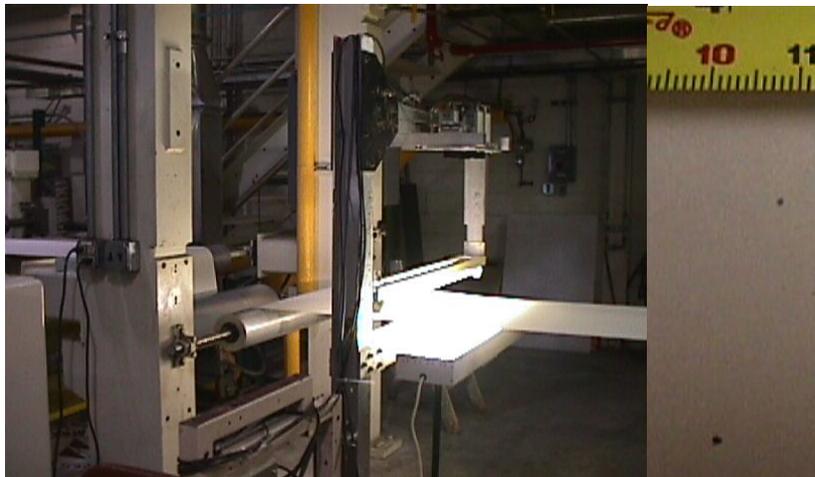
Figure 38 - View of frame during the trial with Newsprint roll A and defects on newsprint.

In this trial run, a lower speed was deliberately used as to avoid continual web break problems. Contrarily to Thursday, the CD position of the web was much better controlled because of some new adjustment made on the pilot coater by operational staff. Below are two photos (Figure 38) depicting the newsprint web again, sagging during the run and a picture of defects actually detected and marked for verification. The divisional ruler used was in metric and divided into centimeter with the small graduations representing millimeters. As seen in the photograph of the defects, the defects were approximately 1 millimeter diameter or larger. This is significant as it does correlate to the sizing set by the RKB operational software program and showed correct sizing and classification during detection.

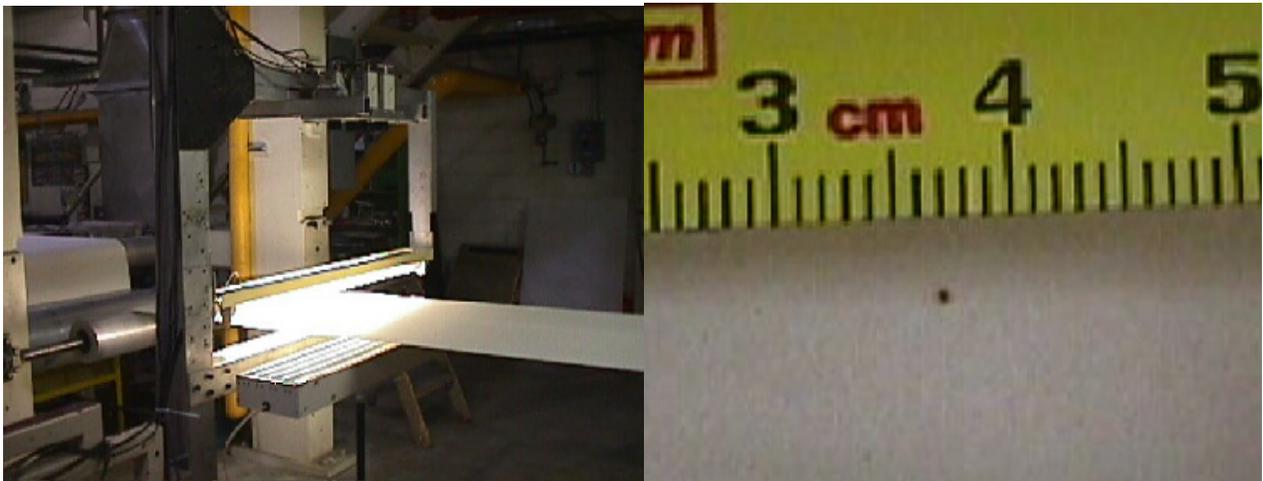
Figure 39 - Camera frame during testing of Newsprint Roll B and a spot defect detected during the run.

Acquisition of data occurred between the 2nd red mark and the black mark (1st red mark was when the coater reached maximum speed of 3500 fpm) at a constant speed of 5000 fpm. No web breaks occurred and the test was completed up to the end at 5000 fpm without any noticeable pilot machine problems. Data files are currently being processed and analyzed. Figure 39 shows the equipment and a spot defect detected during this run.

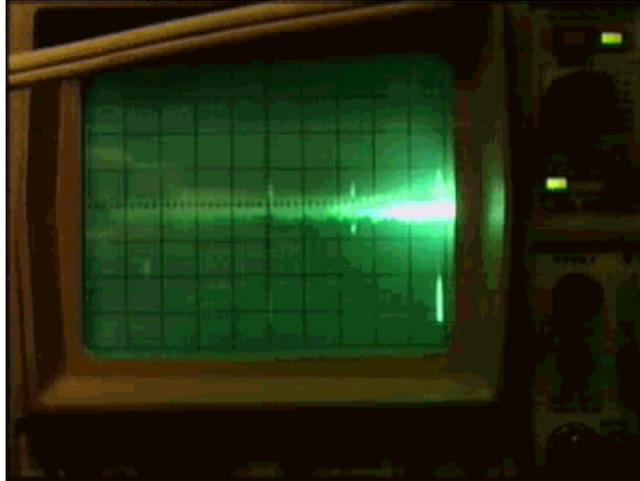
Picture 2 - Signal to Noise 2.5:1
